PHOTOGRAPHIC, RADIOGRAPHIC, AND MICROSCOPIC ASSESSMENT OF DENTAL IMPLANTS AFTER SIMULATED HEATING, BURIAL, AND IMMERSION IN WATER

OBJECTIVES: The present study aimed to analyze photographic, radiographic, and microscopic images of dental implants in three common situations in forensic practice: heating, burial, and water immersion.

J Stoma 2020; 73, 3: 118-122

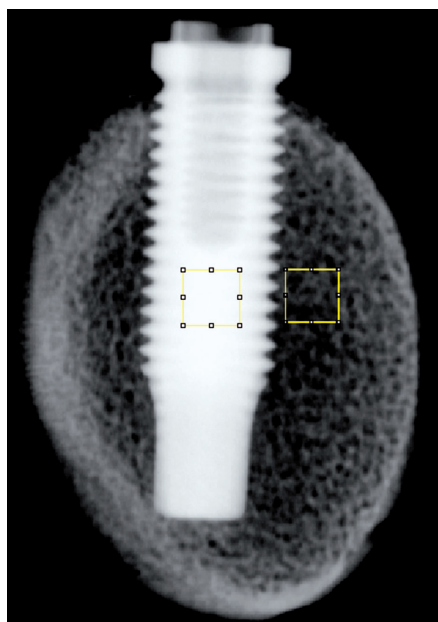
FIGURE 1. 1.5 mm × 1.5 mm ROIs selected in the bone adjacent to the implant and at the center of the implant. The upper limits of the regions of interest (ROIs) were at the level of the ninth screw of the implants

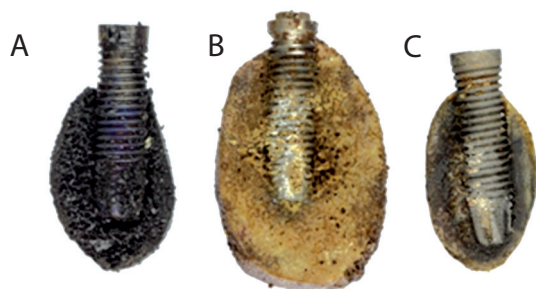
FIGURE 2. Photographic images obtained after submission to each forensic condition

alteration after maximum heating (600°C) and maximum stay under the soil and water (90 days). The only evident sign of heating, burial, and immersion in water was the change of color spectrum to dark (after heating), brownish (after burial), and opaque grayish (after immersion in water) (Figure 2).

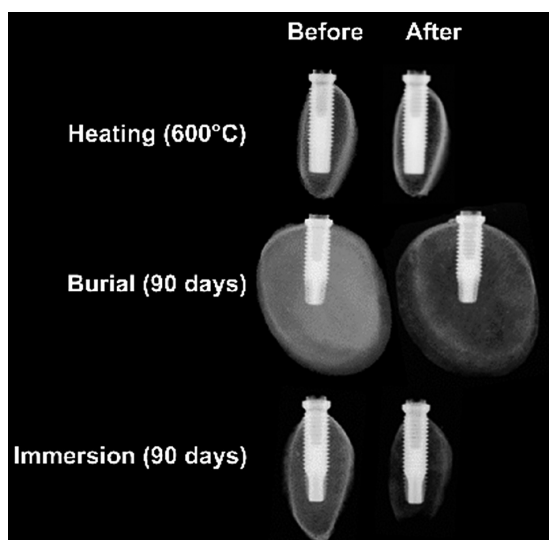
FIGURE 3. Radiographs of heat (600°C), water (90 days), and land (90 days) samples, before and after exposure

In the radiographic analysis (Figure 3), radiolucent defects were more prevalent in implants that underwent heating ($n = 1$ at 200°C, $n = 4$ at 400°C, and $n = 6$ at 600°C) and less prevalent in implants that were buried ($n = 0$ at 30 days, $n = 2$ at 60 days, and $n = 1$ at 90 days) (Table 1). The radiolucent defects were visible in the interface between implant and bone.

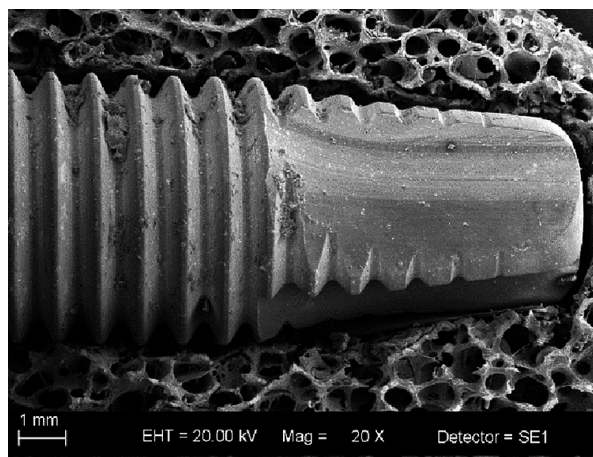
FIGURE 4. Scanning electron microscopy of the implant's apical region and surrounding bone (20x magnification): 400°C heat sample

Through scanning using electron microscopy (magnification of 20×), the qualitative analysis showed differences that were more evident between samples, which underwent heating and immersion. In the former, bone porosity was clearly visible, and the implant was apparently undamaged (Figure 4), while in the latter, a mass covering the implant surface and the adjacent bone was detected (Figure 5).

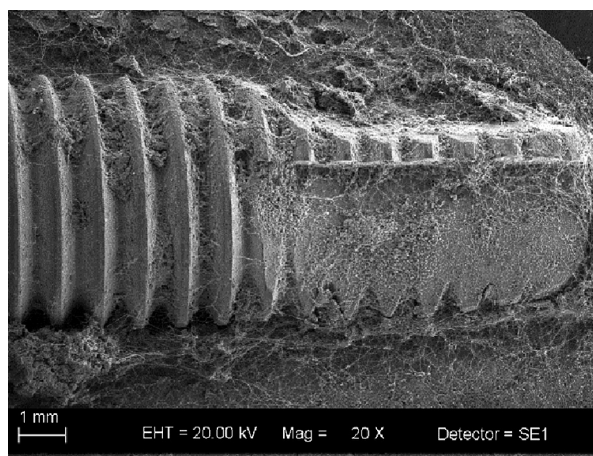
FIGURE 5. Scanning electron microscopy of the implant's apical region and surrounding bone (20x magnification): 30 days immersion sample
